TECHNICAL BULLETIN

REJECTION

Rejection is defined as the inability of a coating to form a continuous film over another surface.

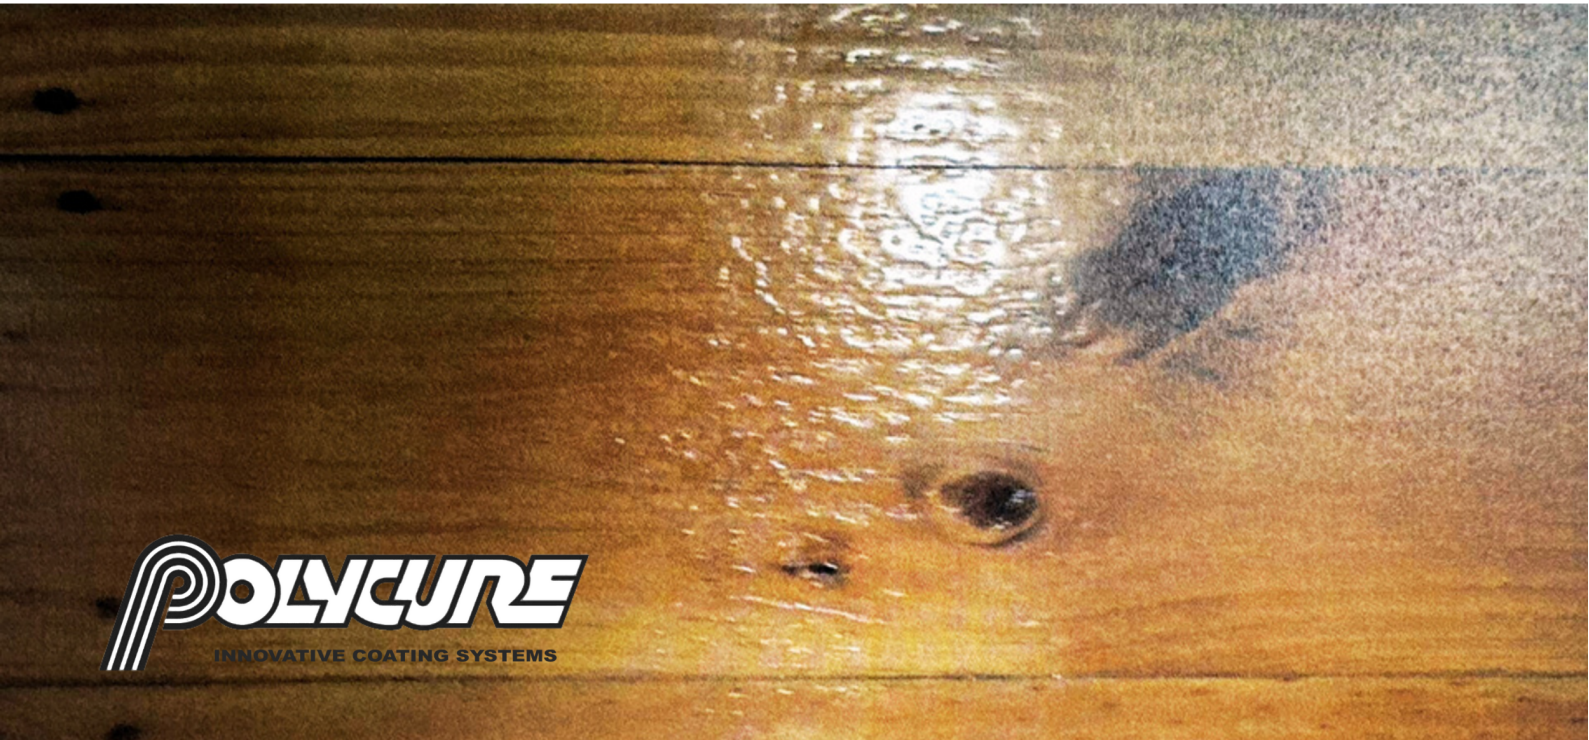
- 'pulling back' from the edges of strip timber or parquetry
- 'pull back' leaving uncoated regions on coated or uncoated substrate
- a 'wax paper and water' effect with the coating wanting to join together with itself rather than 'flatten' or 'level' across the surface to be coated.
